31 August 2020

ASX Release

SM58 G2, Pipeline Installation and SM71 Production Status: Post Hurricane Laura

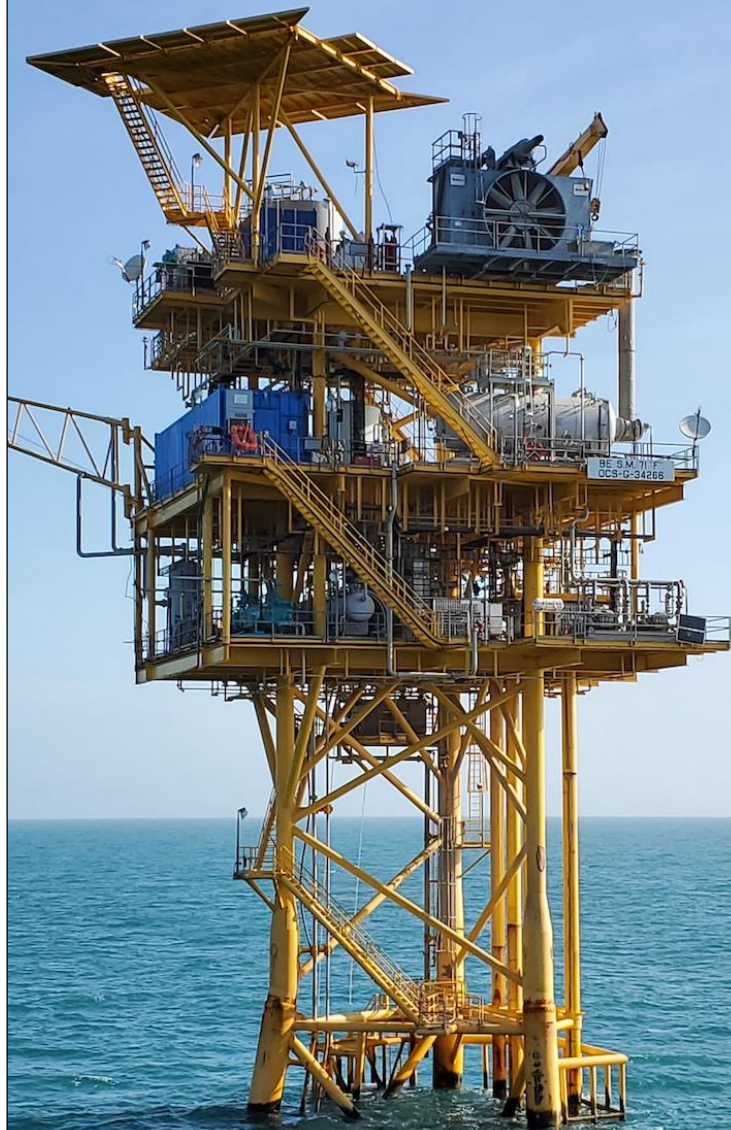
SM71 F Platform
29/08/2020

Production operators at the Byron operated SM71 project also returned to the platform on Friday, 28 August 2020 and found only minor damage. Production was restored late on Saturday 29 August 2020 after clearance was given by oil and gas pipeline operators.

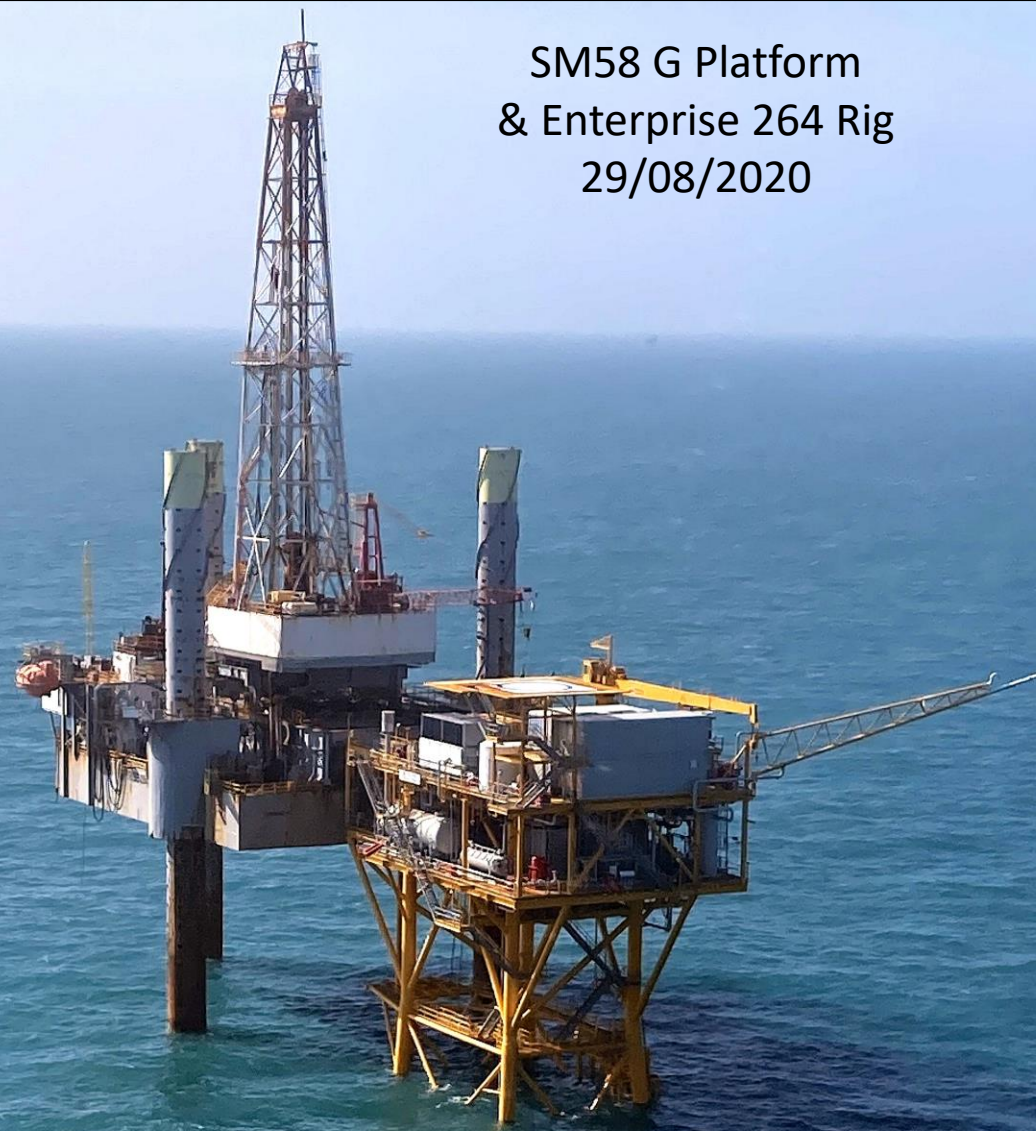
SM58 G Platform
& Enterprise 264 Rig
29/08/2020

As of Sunday, 30 August 2020 (USCDT), the SM58 G Platform and the EOD 264 were both fully manned and operations to return to drilling were underway. A full complement of third party vendor personnel will be on board within the next 24 hours and will begin the installation and testing of blow out preventer equipment on the G2 well which will allow the safe removal of
