Fletcher Building dismisses BGC claims and provides detailed update on causation research to date

Auckland, 13 October 2023: Fletcher Building Limited has today issued a detailed update on the cause of the plumbing failures that have occurred in a number of homes built in Perth during the period 2017 – 2022, along with the activities Iplex Australia is undertaking to support industry and homeowners in finding the right solution.

The evidence points to installation as the root cause of the Perth plumbing leaks.

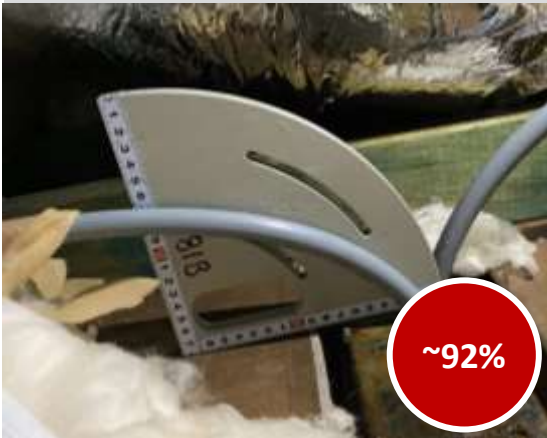
1 OVER-BENDING

The Iplex Pro-fit Technical Guide states that the minimum bending radius be 10 times the outside diameter of the pipe. If this is not possible an IPLEX Pro-fit® elbow should be used.

Pipe overbent

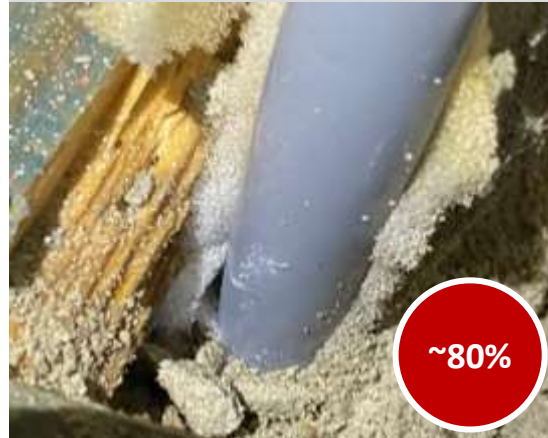
2 INADEQUATE MOVEMENT

Iplex installation instructions state that care must be taken during install to allow for potential thermal movement of the pipe. Additionally, Australian standards require pipes to be supported with adequate brackets, clips or hangers with defined maximum spacings.

Pipe fixed in the wall through rigid mortar

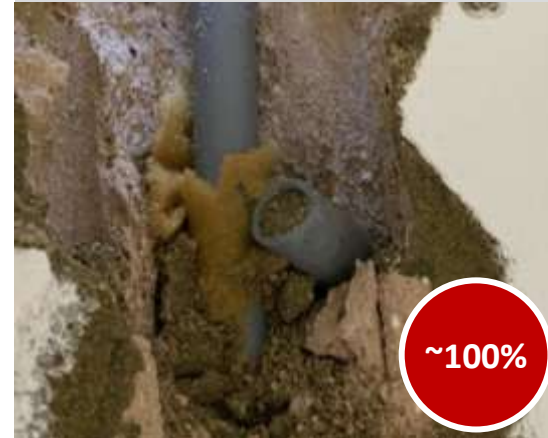
3 POOR LAGGING

Plumbing standard AS/NZS 3500.1&4 and Iplex installation instructions state that pipes in chases shall be continuously wrapped with an impermeable flexible material.

Lagging not impermeable (and at times non-existent)

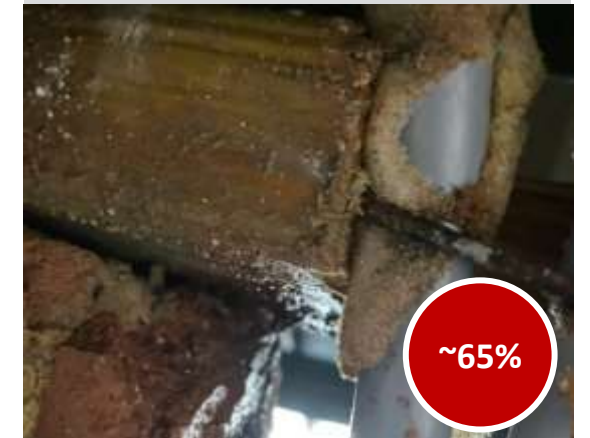
4 DAMAGE / WORKMANSHIP

Plumbing standards AS/NZS 3500.1&4 and Iplex installation instructions note that care should be taken to ensure pipes are not damaged during normal building activities.

Pipe bend across metal nail and kinked, resulting in a stress point

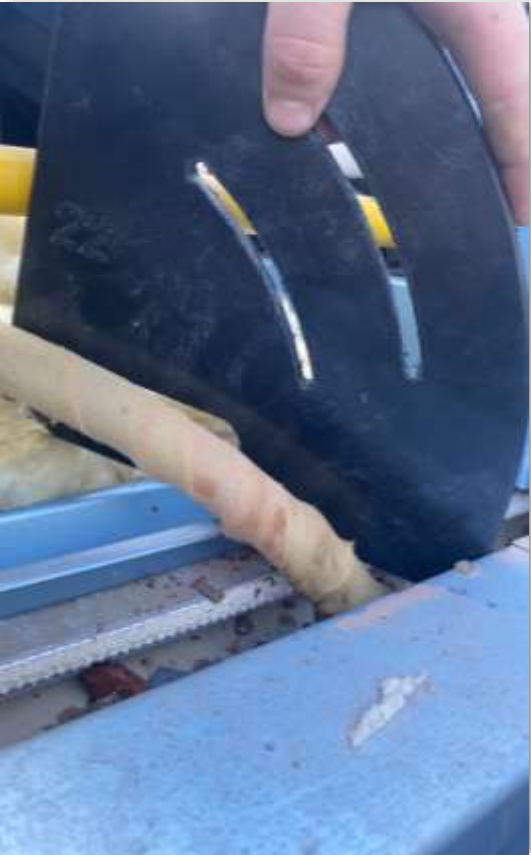
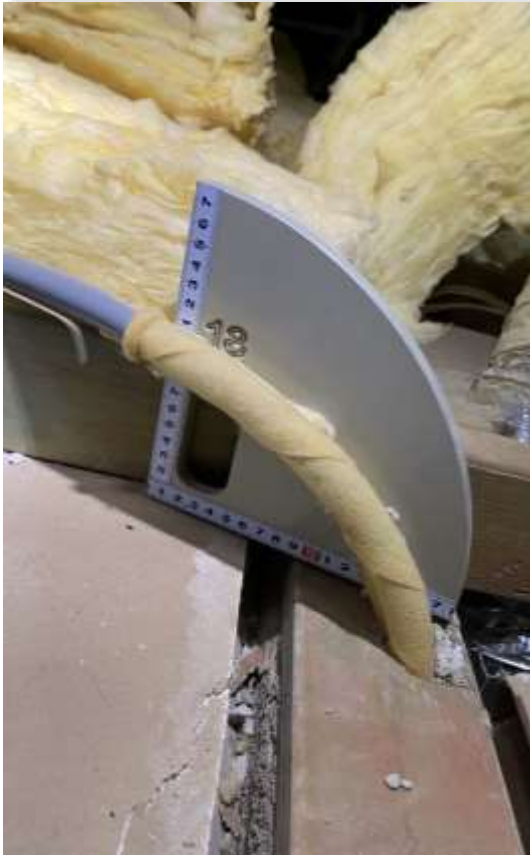
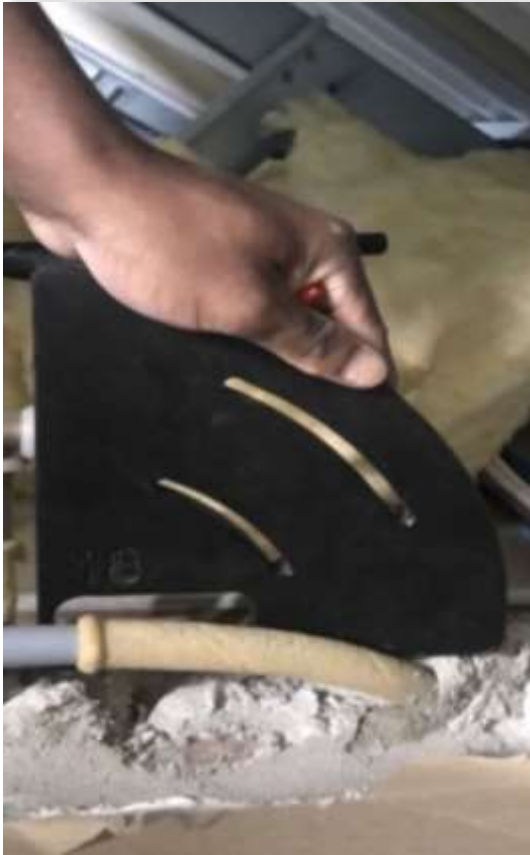
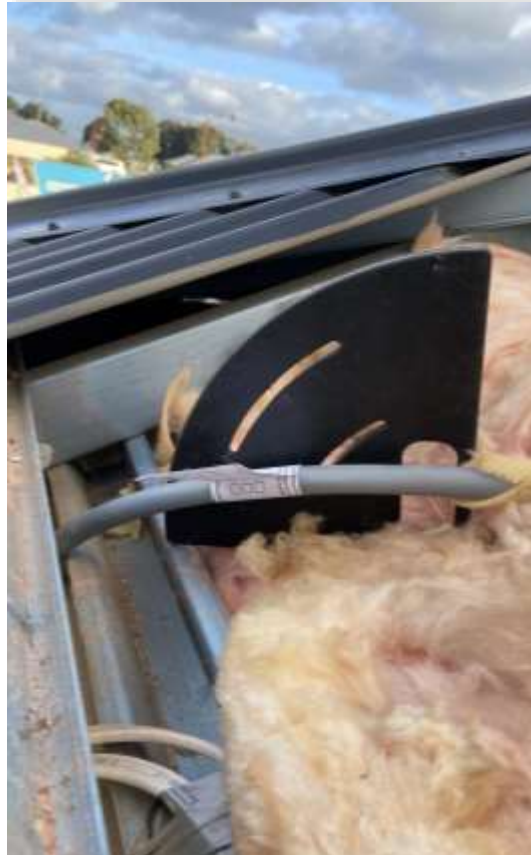
~92% of homes we have inspected / repaired have had non-compliant radial bends

Minimum bending radius must be 10 times the outside diameter of the pipe. All of the pipes shown here have been over-bent

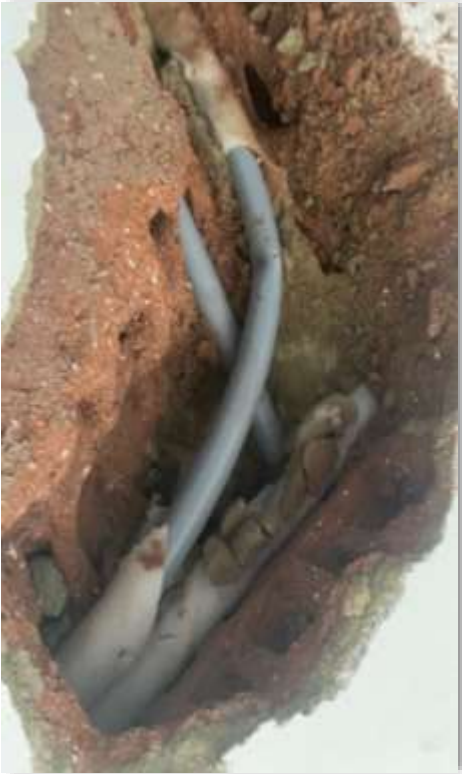
Kinked or damaged pipes, pipes overlapping; tight bend on back pipe

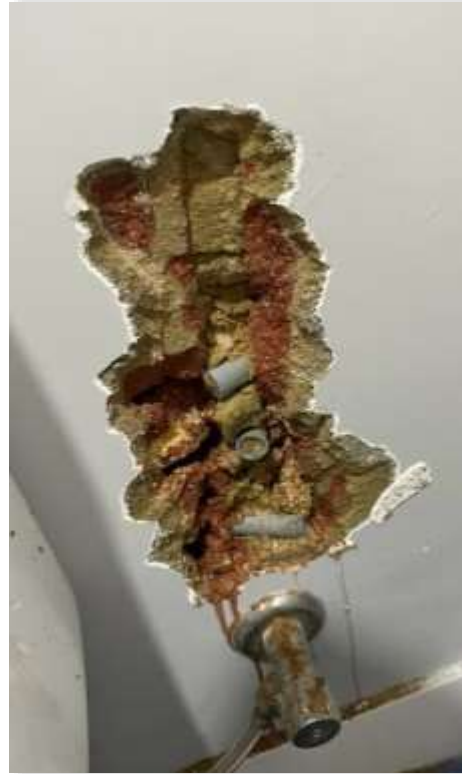
Pinch/pressure point caused by pegging creating localised high stresses

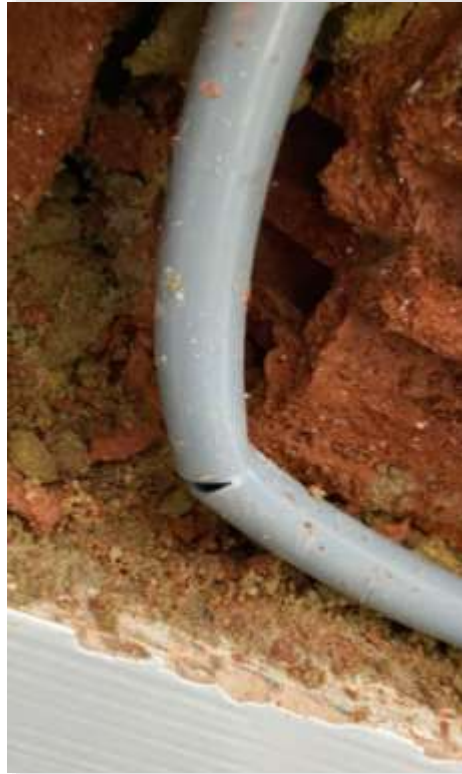
Kinking or damaged pipe not replaced per guidelines

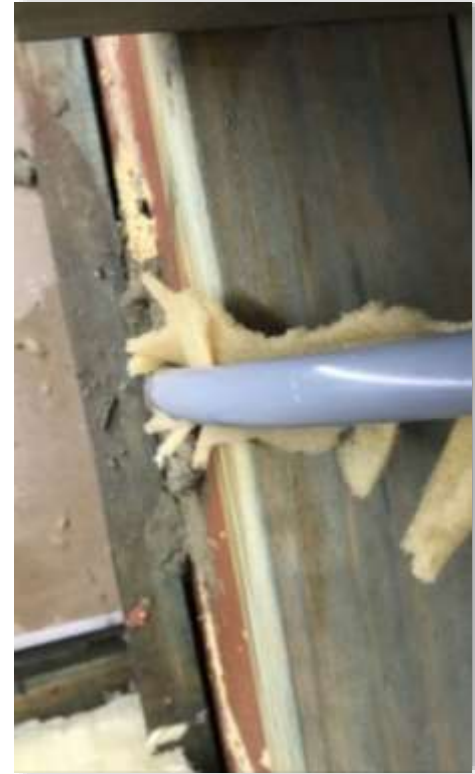
Pulled hard against timber not allowing for lineal thermal expansion per guidelines

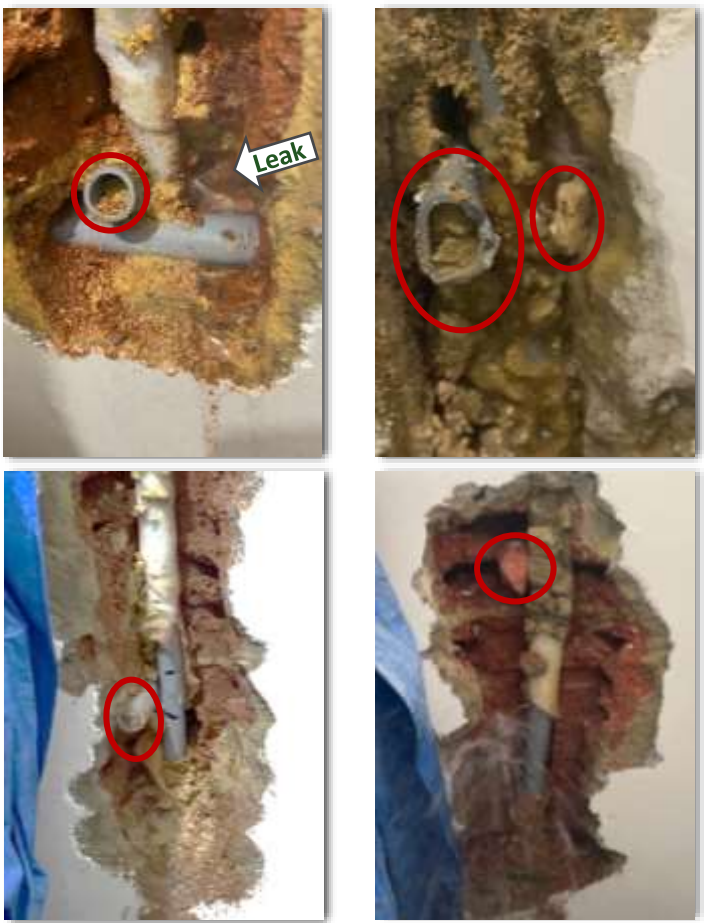
'Pegging' is a process that uses a fixed object to hold the pipe during installation which that installation instructions require to be removed prior to the system being put into service.

Inadequate movement and damage to pipe caused by pegging left in chase

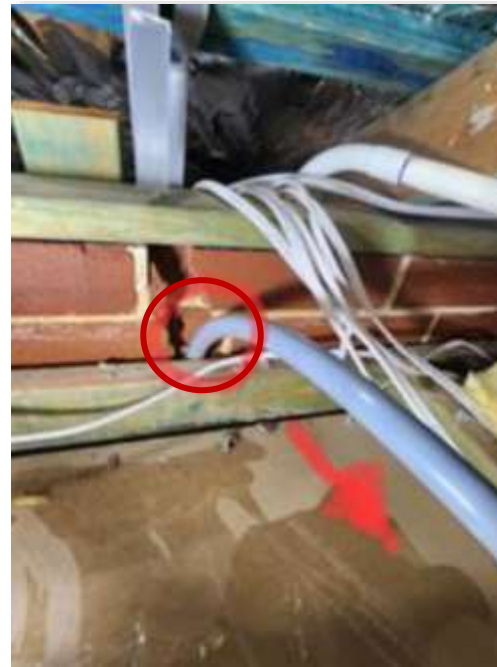
The bend of these pipes are likely to be outside of Iplex Pro-fit instructions (too tight), placing stress on the pipes

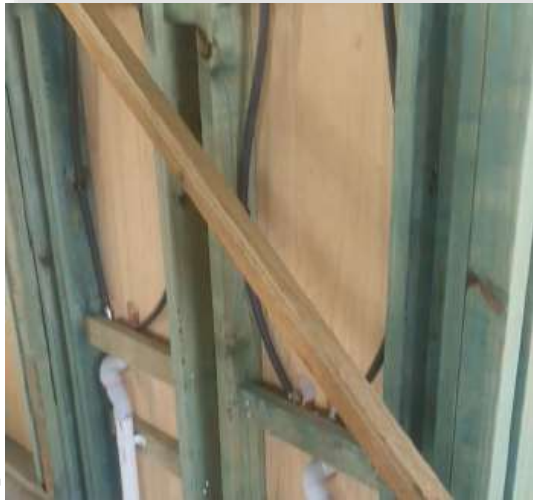
Timber frames allow the pipe to be installed within the open space of the wall cavity, allowing for **adequate movement due to thermal expansion and contraction**, while still being supported with sufficient clipping.

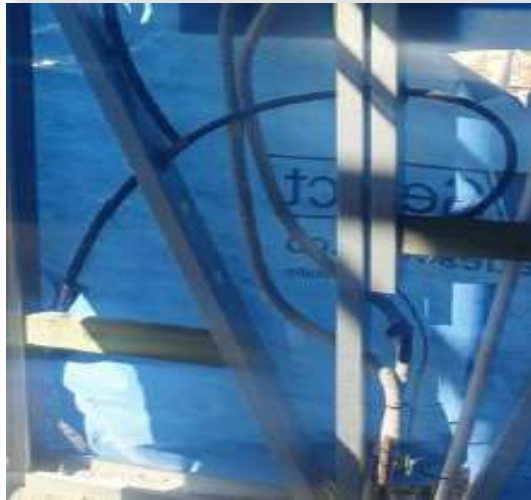
While tight bends are still visible in these images, the pipes are able to **freely expand and contract within the open wall cavity** during expected regular changes in the pipe's temperature and pressure (e.g. water hammer).

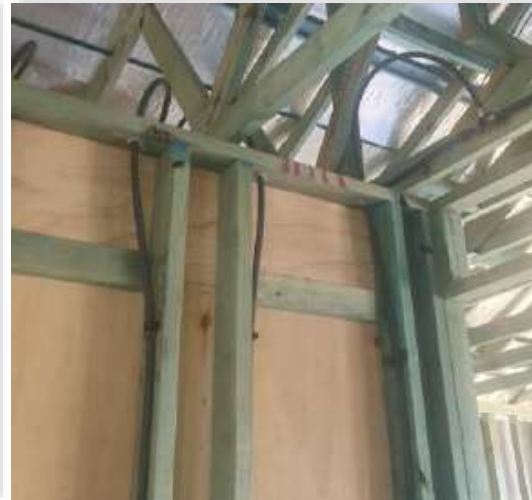
Holes cored in the top plate allow for **adequate movement** of the pipe due to thermal expansion and contraction without being held tightly by a mortar fill.
