Fletcher Building dismisses BGC claims and provides detailed update on causation research to date

Auckland, 13 October 2023: Fletcher Building Limited has today issued a detailed update on the cause of the plumbing failures that have occurred in a number of homes built in Perth during the period 2017 – 2022, along with the activities Iplex Australia is undertaking to support industry and homeowners in finding the right solution.

The evidence points to installation as the root cause of the Perth plumbing leaks.

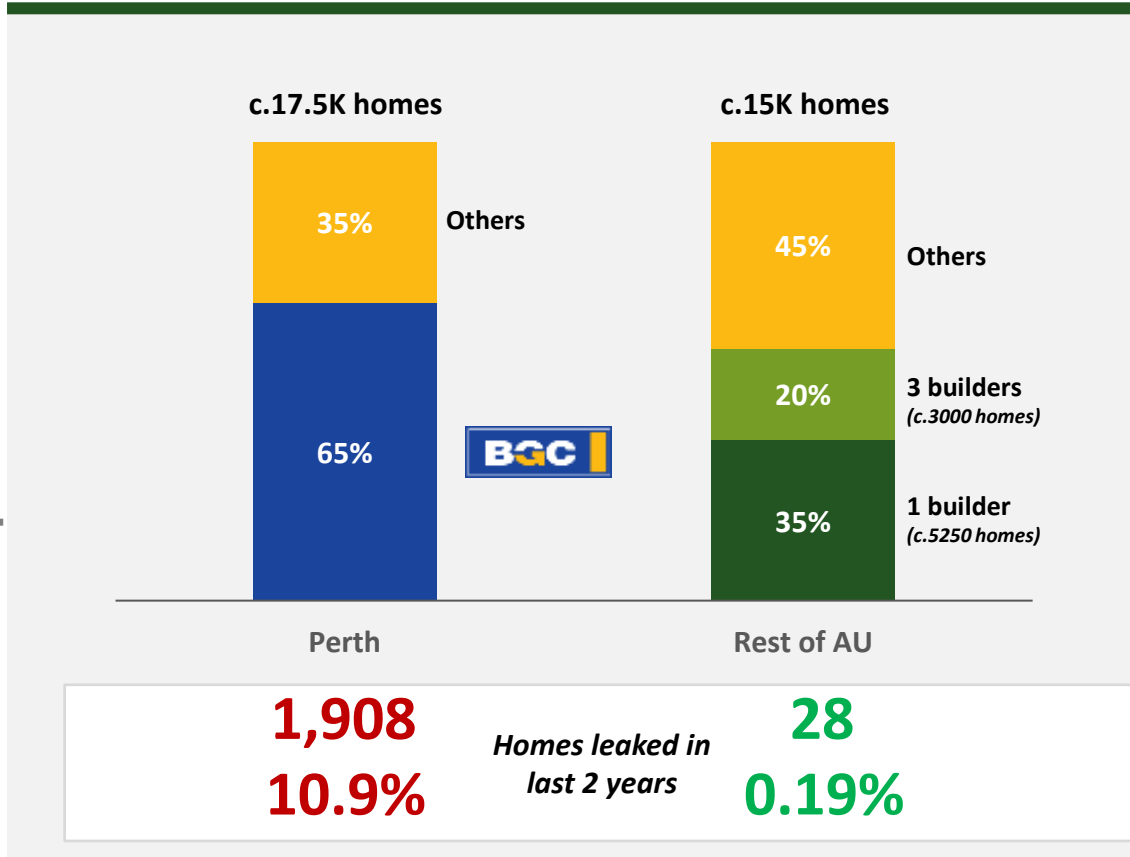
Homes built with Pro-Fit (mid 2017 – 2022)

- ➔ Similar volumes of Pro-Fit sold in Perth and rest of AU from 2017-2022
- ➔ Iplex has reached out to all our merchants and major plumbers / builders on the East Coast – they report no abnormal leak rates

- ➔ **Over the last 2 years, we have been made aware of only 28 homes in the rest of AU that have been impacted by plumbing failures involving Iplex pipe in homes built since mid-2017.**

- ➔ **Of these 28 homes, only 1 was determined to have a manufacturing defect with 8 yet to be determined/tested**
- ➔ BGC is misrepresenting the role of the failures it refers to in Victoria. These are known to Iplex and captured in our data. All tests completed on samples provided so far from that builder have not found any manufacturing fault.

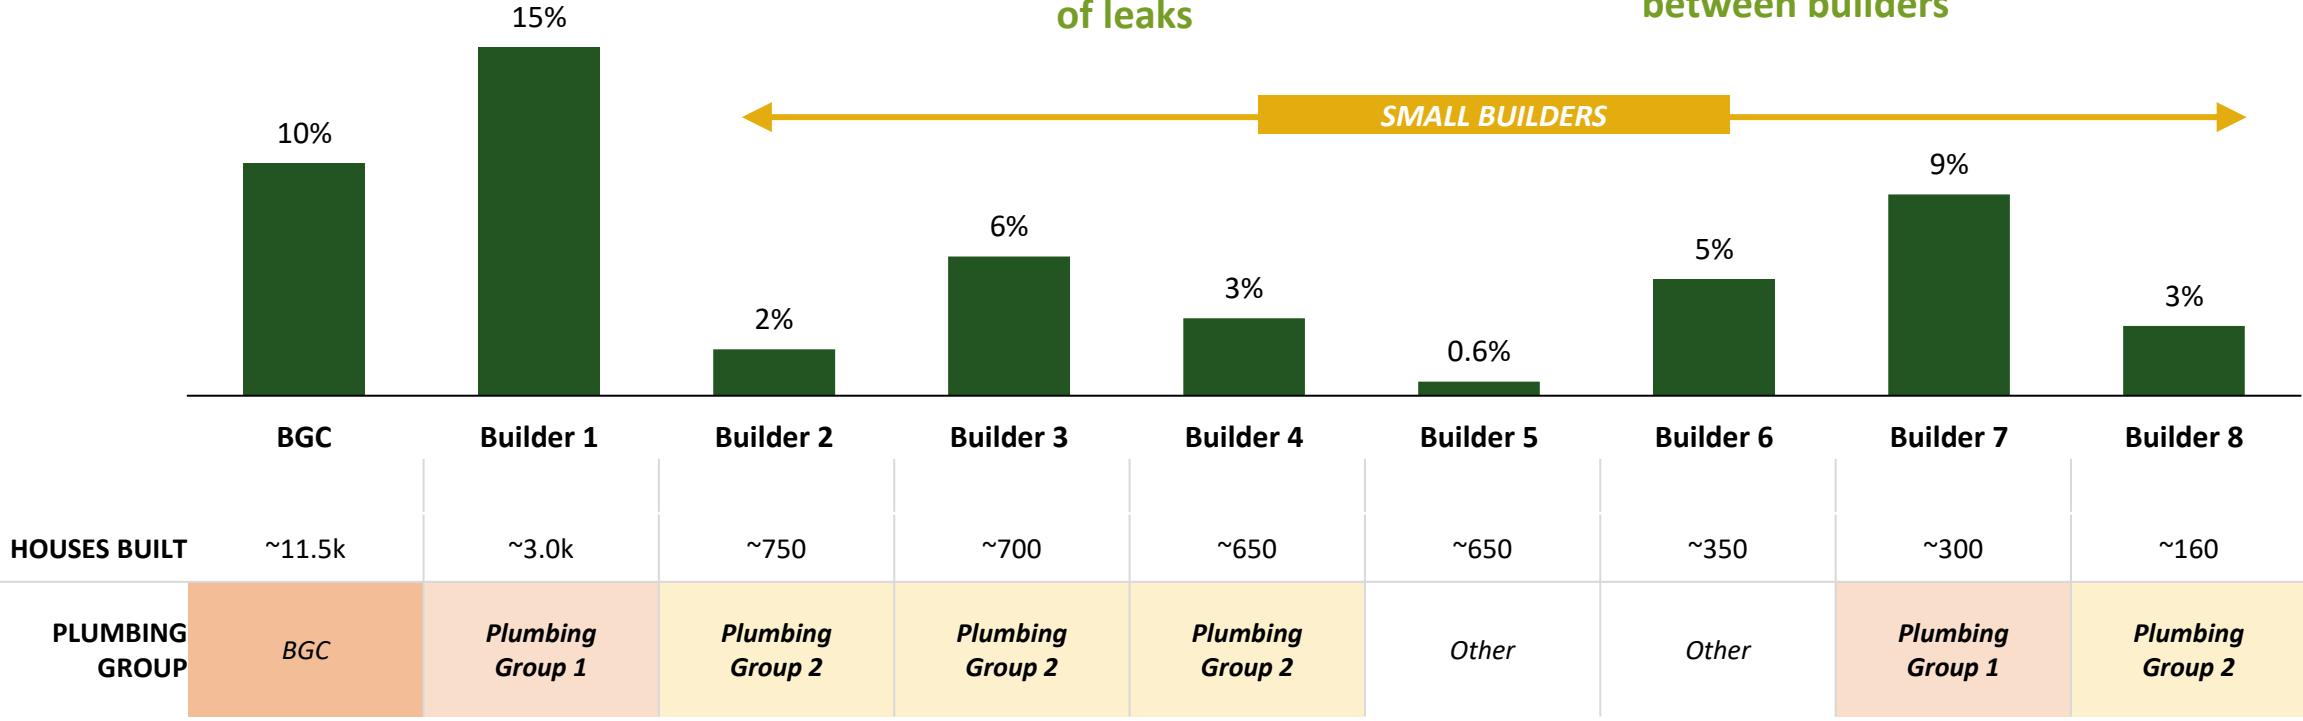
Plumbing failure rates
 (% of plumbing failures¹ / homes built between 2017-22)

1 BGC and two plumbing groups account for **94%** of leaks

2 Significantly different plumbing failure rates between builders

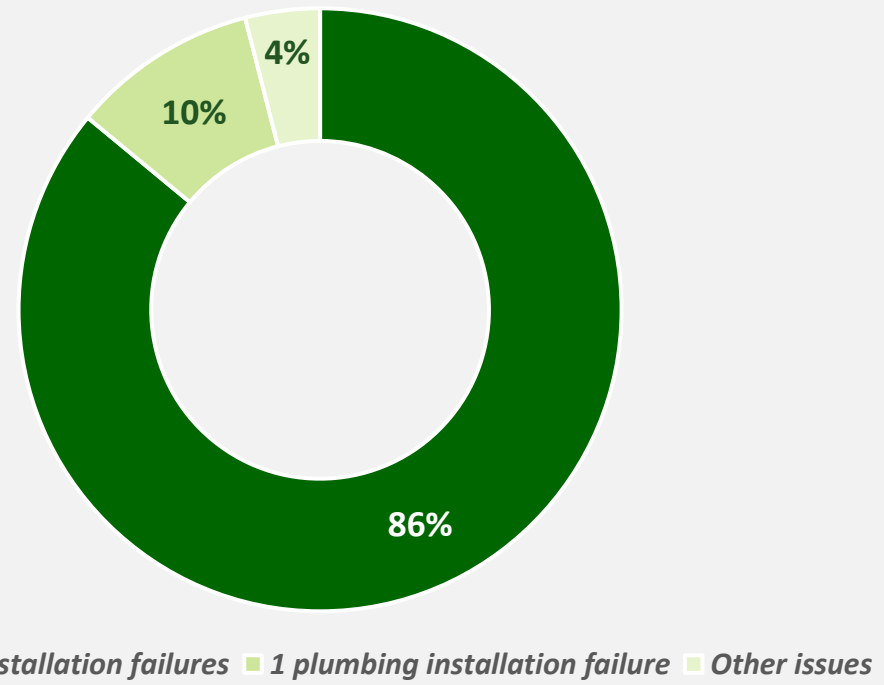
Data as at 24th September

96% of homes have at least 1 installation failure. 86% have multiple installation failures

Plumbing installation failings seen across home inspections

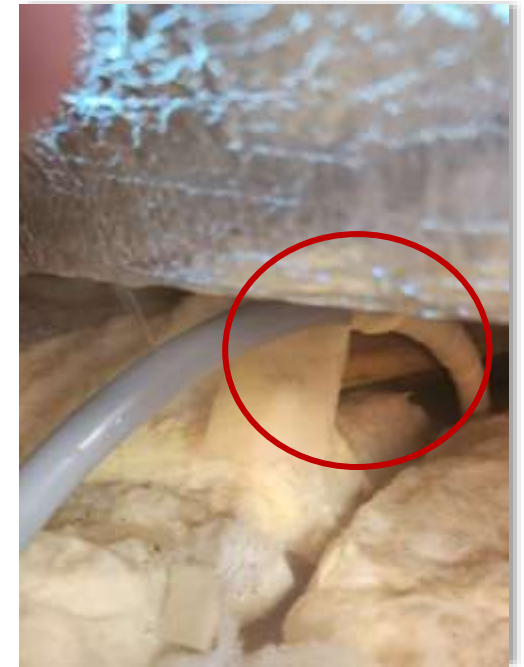
The bend of these pipes are likely to be outside of Iplex Pro-fit instructions (too tight), placing stress on the pipes

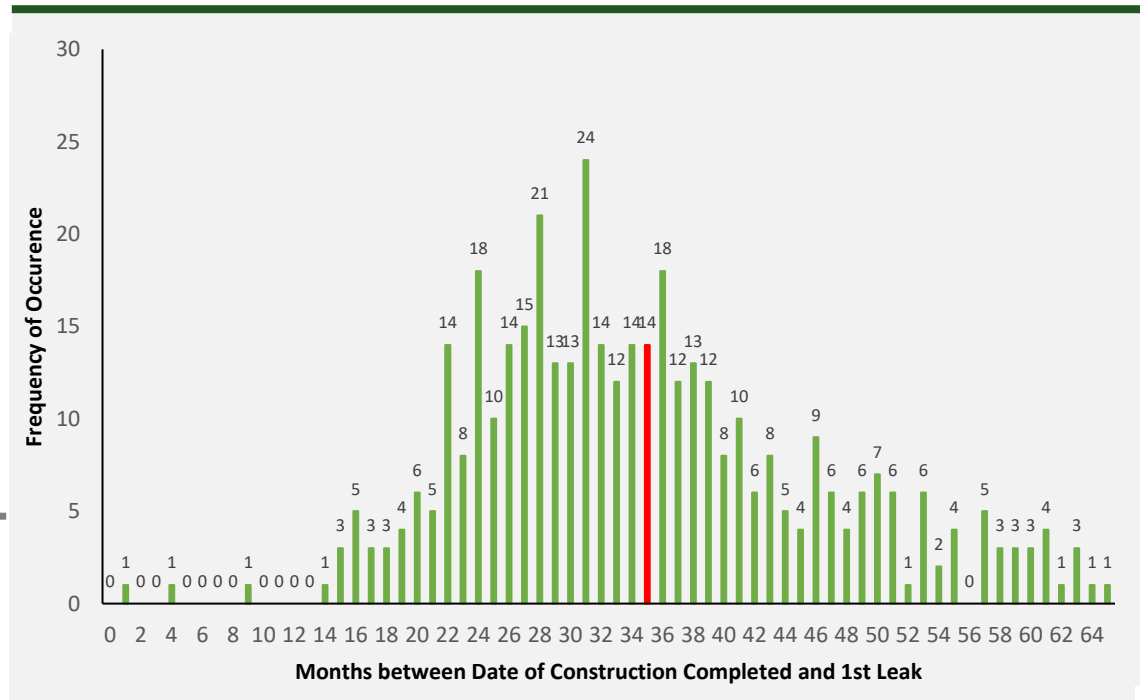
Time from construction completed to 1st leak (in months)

- Graph shows the average period of time from house build date to a home's first leak is 35 months
- Houses are unlikely to leak after 5 years have past the construction date

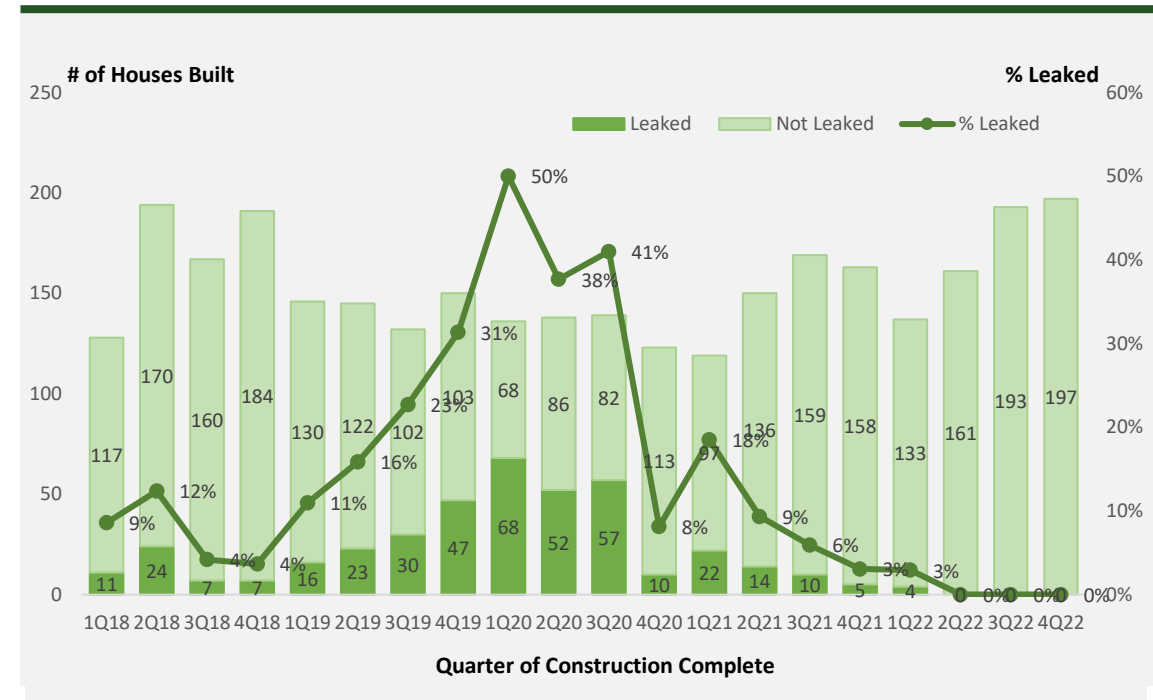
Leak rate by house build period

- Graph show which houses have leaked and not leaked by construction period
- House built between 4Q19 and 3Q20 have a much higher leak rate (financial years)
- Homes built prior to 4Q19 are leaking at a much lower rate and those that have not been affected have a low probability of leaking

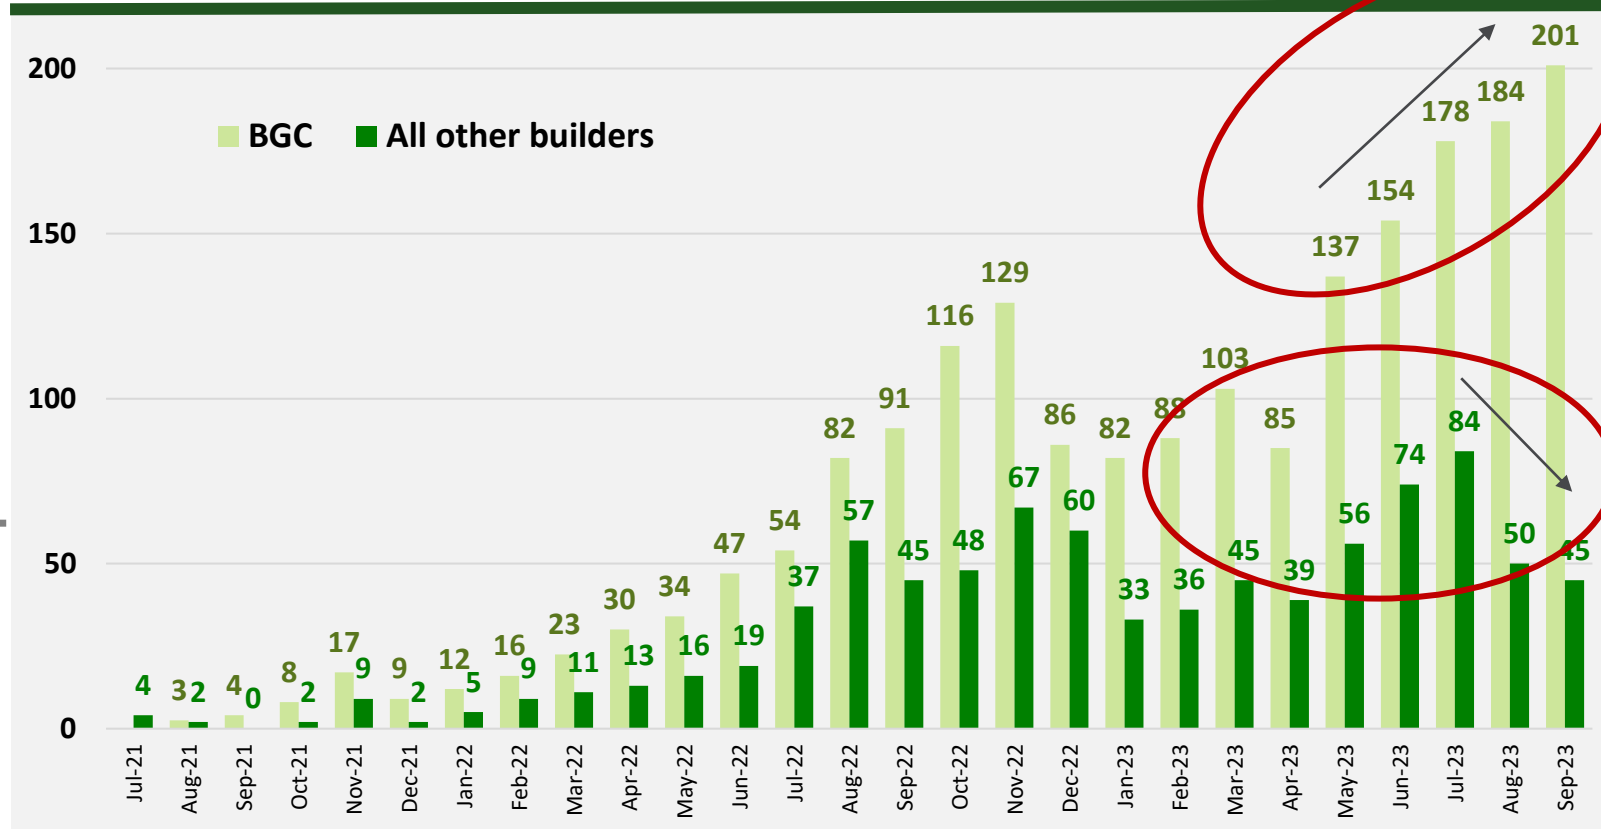
Plumbing failures (Jul 21 – Sep 23)

- BGC claims the situation is getting worse and we are only seeing the tip of the iceberg
- We are seeing the opposite trend with other builders who we are working with
- We have been proactively funding the replacement of ceiling pipes for 5 months now with Delstrat. BGC was provided the same offer, but declined.
- The builders we are working with have seen a ~46% reduction in leaks since July
