LION ONE: TUVATU GOLD MINE CONSTRUCTION IS 75% COMPLETE

North Vancouver, B.C., June 29, 2023 - Lion One Metals Limited (TSX-V: LIO) (OTCQX: LOMLF) (ASX: LLO) ("Lion One" or the "Company") is pleased to provide an update on construction progress at its 100% owned Tuvatu Alkaline Gold Project in Fiji.

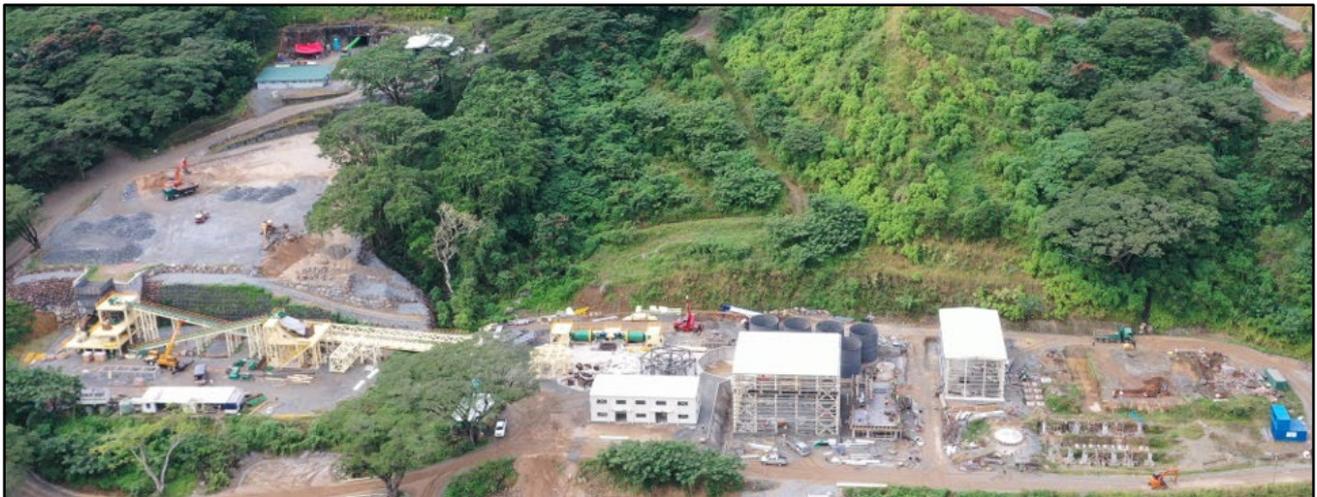
Figure 1. Tuvatu Gold Mine Under Construction. See below for additional images.

Mine construction is approximately 75% complete and remains on track for delivery of first gold in Q4 2023. Earthworks and concrete works are substantially complete, with over 3,500 m³ of concrete poured to date. Structural steel is 70% complete and is progressing rapidly. All the components required to commission the processing plant are on site and a team of 350 contractors and employees are working together to bring the project towards completion. Once complete, Lion One plans to operate the processing plant at an initial production capacity of 300 tonnes per day for the first 18 months of operations before increasing the capacity to 500 tonnes per day in mid-2025. Lion One is fully funded to complete mine construction and bring the Tuvatu Alkaline Gold Project into production by the end of the year.

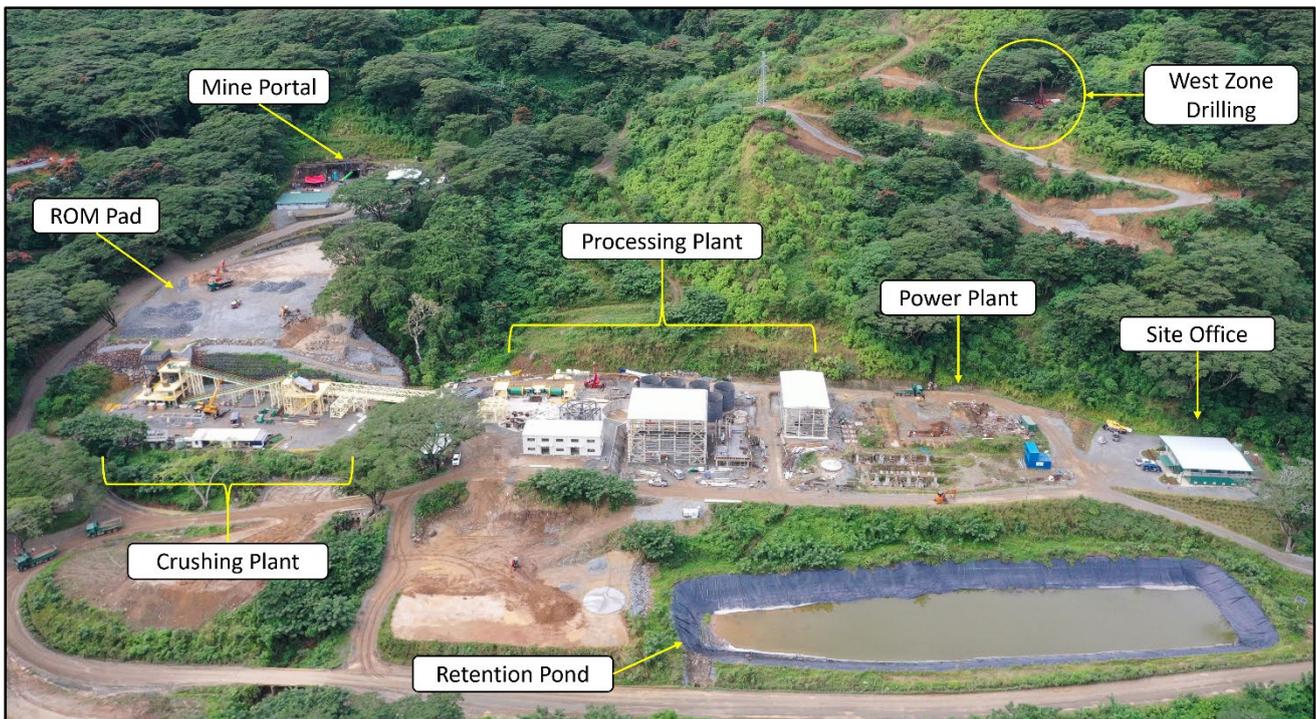
Figure 2. Oblique aerial view of mine site under construction, June 16, 2023.

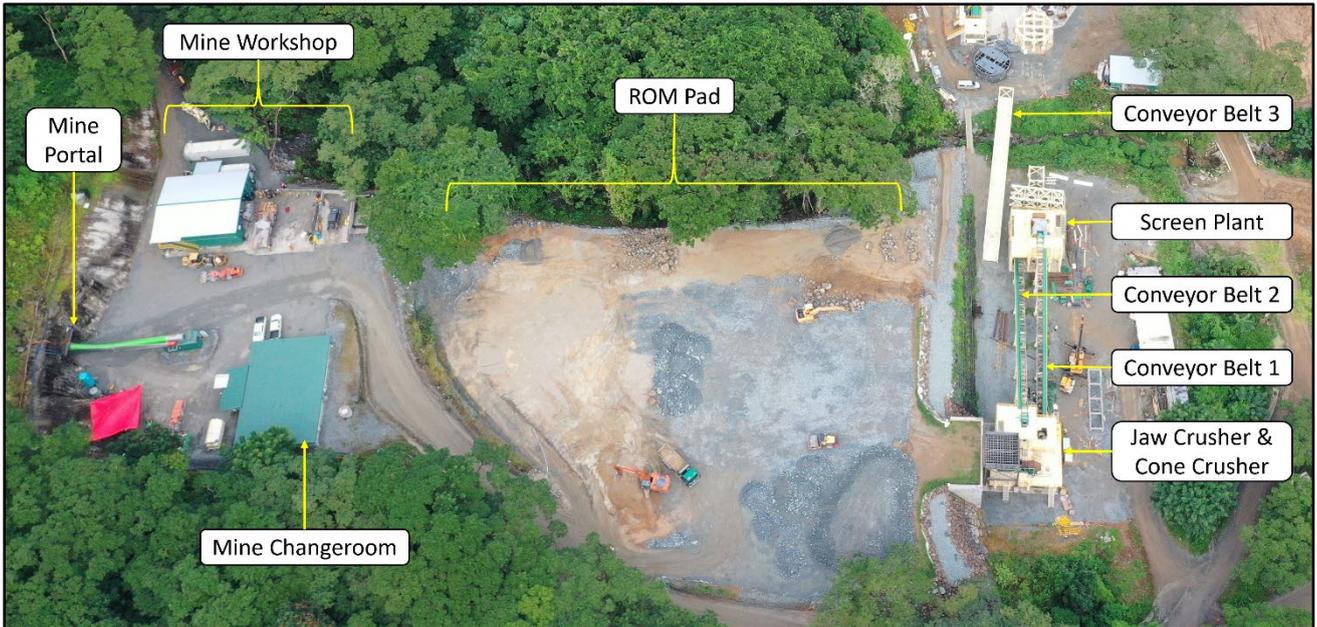
Figure 3. Aerial view of mine portal, ROM pad, and crushing plant, June 16, 2023.

The Lion One processing plant will treat material using a two-stage crushing process, with a primary jaw crusher and a secondary cone crusher. A system of three conveyor belts will transport material between the two crushers and on to the processing plant. The jaw crusher, cone crusher, conveyor belt 1 and conveyor belt

2 are all in place while conveyor belt 3 has been fabricated and needs to be lifted into place. Piping and electrical work remains to be completed. The ROM pad has also been constructed and is in use, with minor upgrades remaining to be completed.

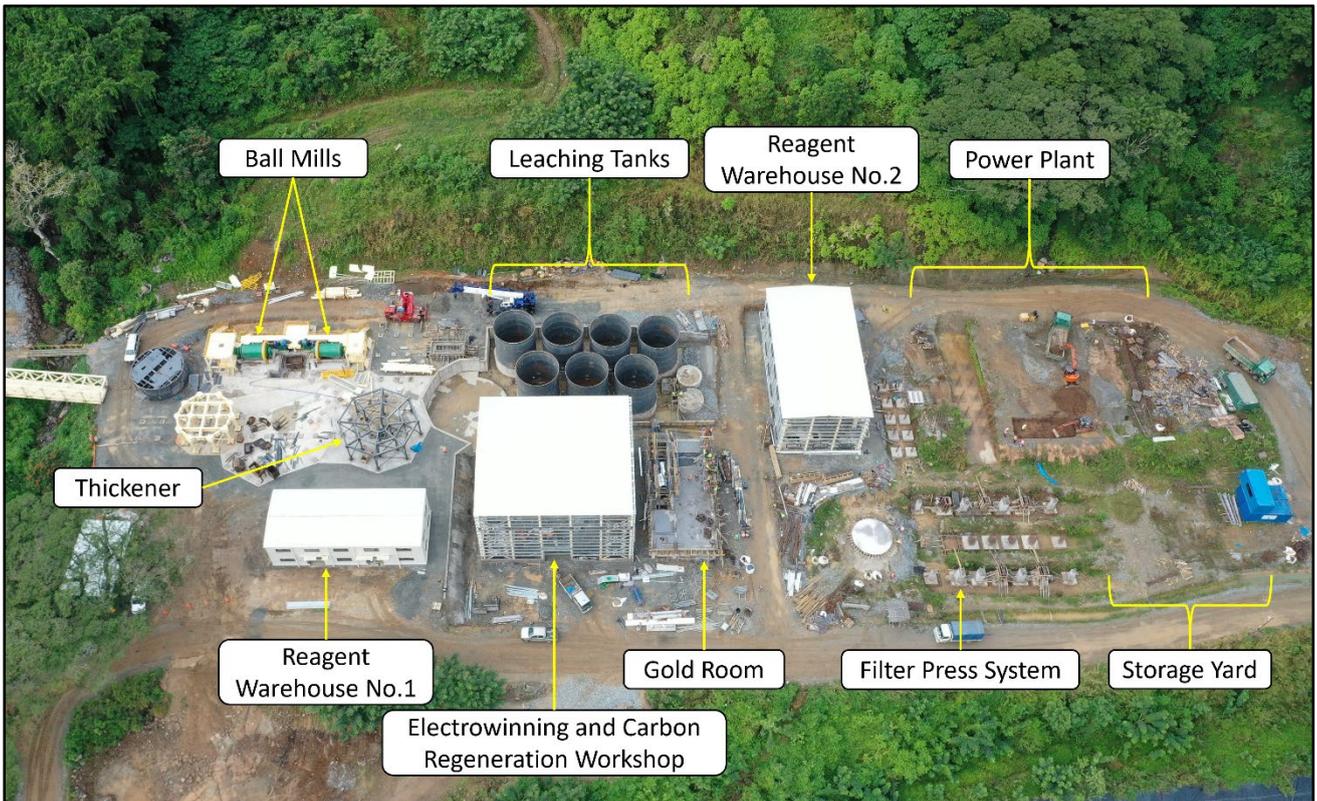
Figure 4. Aerial view of processing plant.

Material from the crushing process will be fed to a two-stage grinding circuit, followed by an integrated two-stage gravity concentration circuit. Some concentrates will then be treated by an intensive cyanide leaching reactor and the remainder of the concentrates will be leached using conventional cyanide Carbon in Leach (CIL) technology. Gold will be recovered from the gold laden carbon using conventional absorption desorption recovery (ADR) technology and smelted on site to produce gold doré bars. Construction is advancing rapidly on the grinding, concentrating, and leaching circuits, as well as on the necessary supporting infrastructure such as warehouses and workshops. Ball Mills 1 and 2 are in place, the leaching tanks are in place, and Reagent Warehouse 1 is nearing completion. All other components of the processing plant are in progress at varying levels of completion. Electrical and piping work remains to be completed.

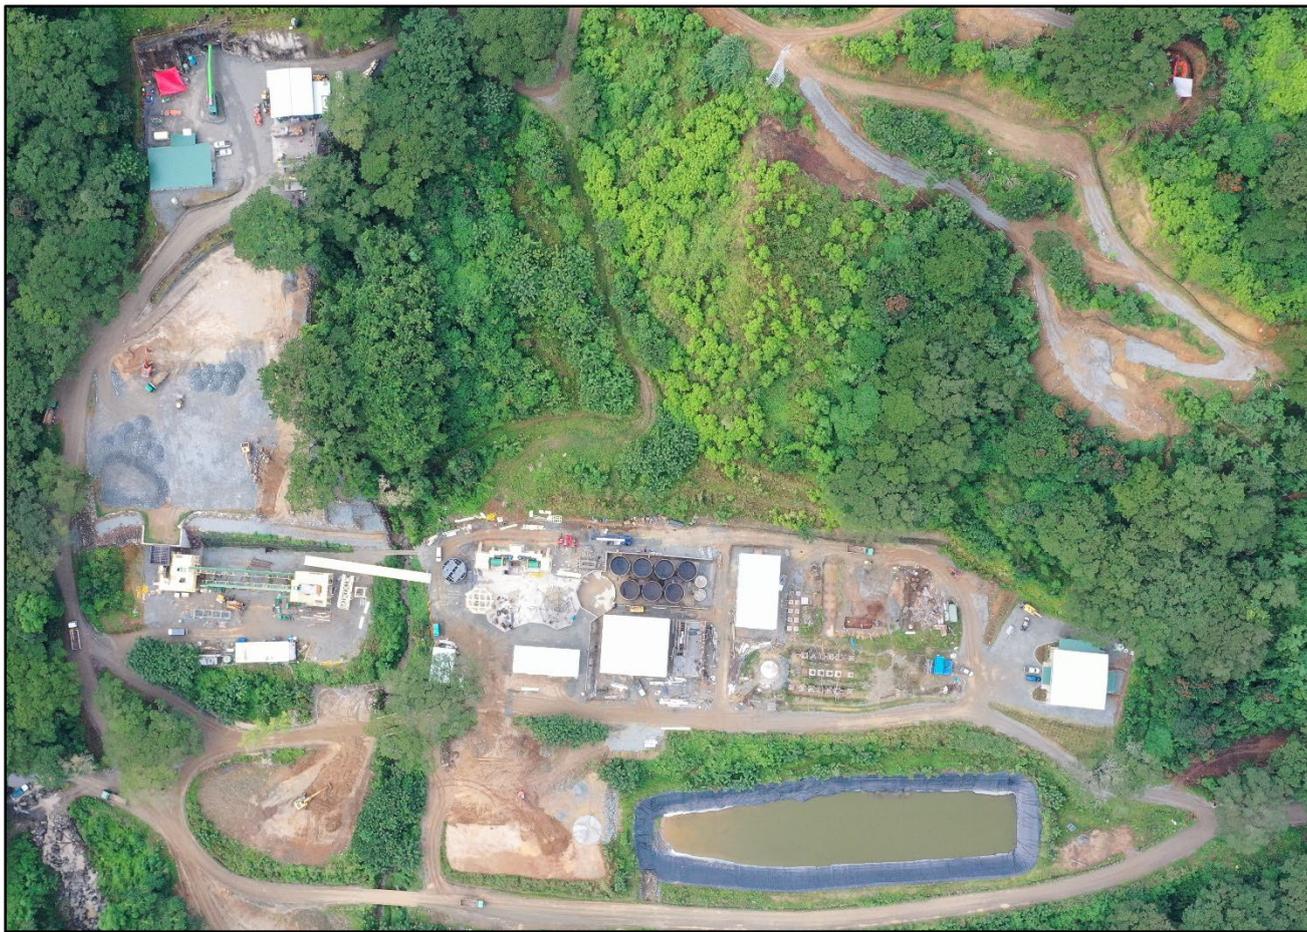
Figure 5. Vertical aerial view of mine site under construction, June 16, 2023.

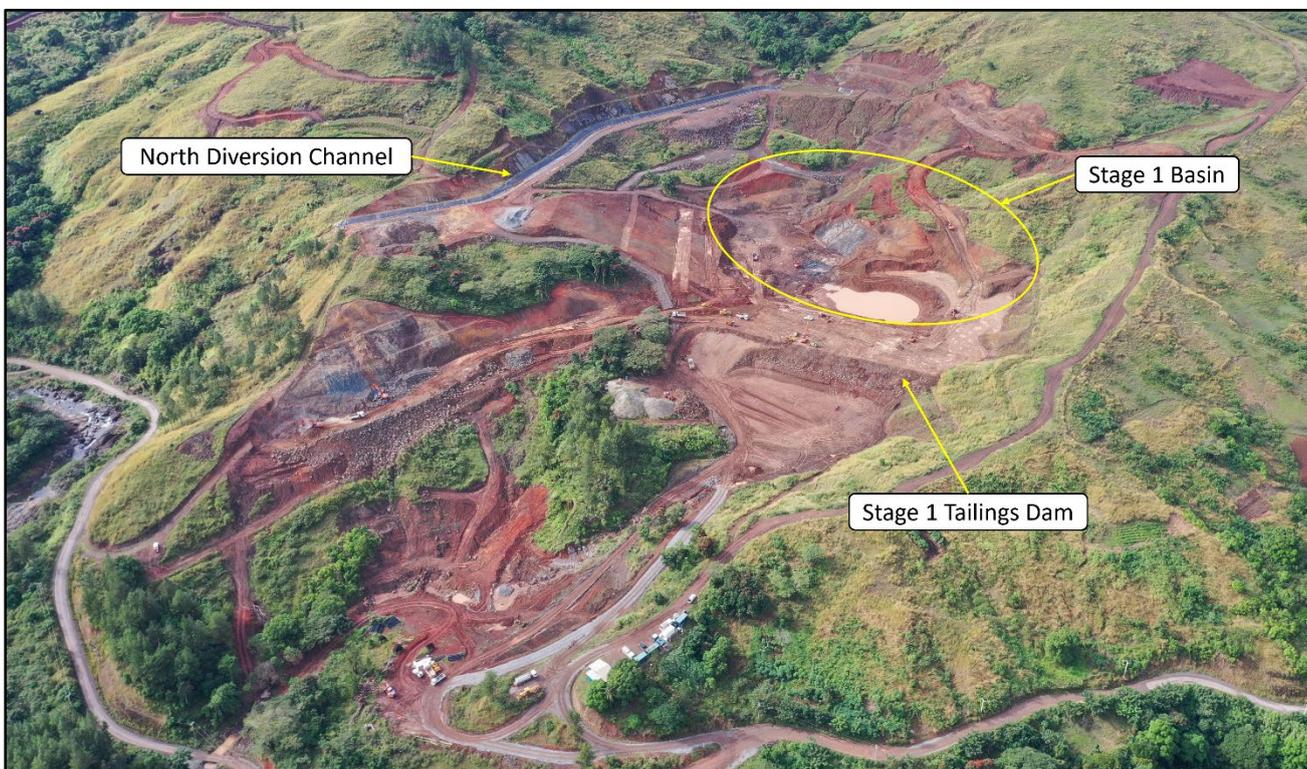
Figure 6. Aerial view of TSF under construction, June 16, 2023.

Tailings from the processing plant will be treated using the SO₂/air process to remove any residual cyanide and will be filtered to produce filtered tailings which will then be transported to the TSF for storage. Stage 1 of the TSF will consist of a dam with a finish level at 115 m elevation, and a pond with enough capacity for 18 months of operation. The tailings dam has currently been built to an elevation of 107 m. TSF construction has been ongoing since June 2022 and the TSF is anticipated to be in operation in Q4 of 2023. Other components of the TSF, such as diversion channels, dam spillway, and liner installation are advancing simultaneously.

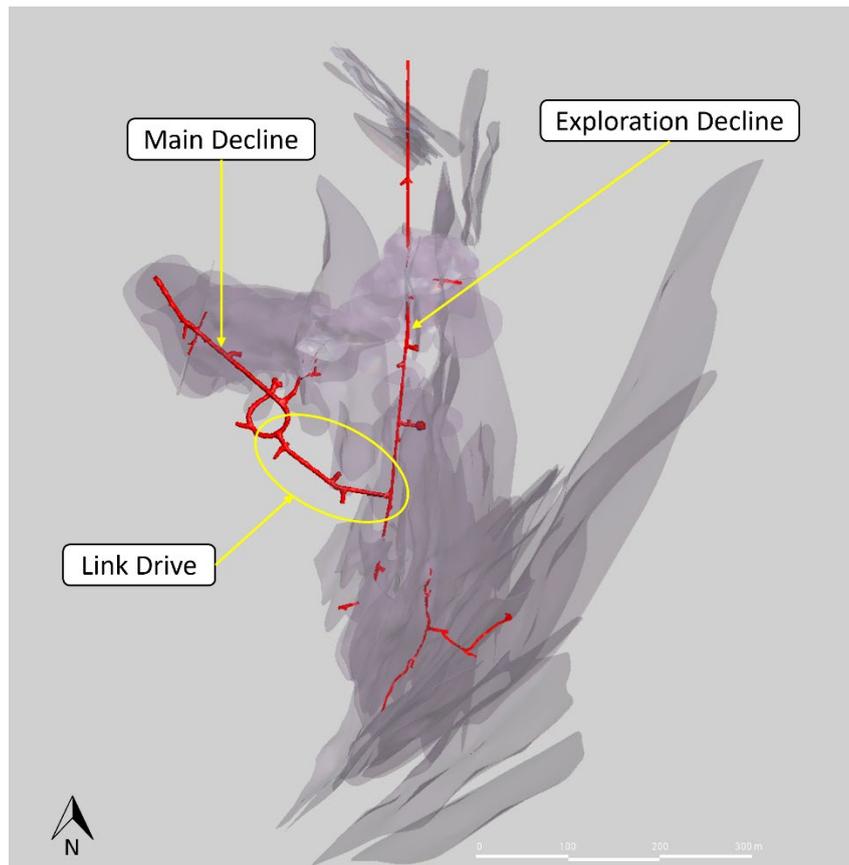
Figure 7. Location of link drive in relation to the main decline and the historical exploration decline. Mineralized lodes are shown in transparent grey. Connecting the main decline to the exploration decline enables the Stage 1 primary ventilation system to be installed and enables mining of the lodes accessed through the exploration decline.

Underground mining of the [URA1](#) , [URW1a](#) and [URW1b](#) lodes is ongoing. The main decline has reached a vertical depth of 99.4 m below surface and a total length of 344 m from the mine portal. The link drive connecting the main decline to the historical exploration decline has been completed and measures 140 m from the junction with the main decline to the junction with the historical exploration decline. The link decline was driven from the main decline to the exploration decline and broke through the exploration decline on June 21st, 2023.

The completion of the link drive is a major milestone in the development of the mine as it enables the Stage 1 primary ventilation system to be installed. The Stage 1 primary ventilation system consists of four 55KW exhaust fans that are being installed at the entrance to the historical exploration decline, and which will provide ventilation throughout the mine. The Stage 1 primary ventilation system will provide sufficient ventilation to mine all the way down to the 500 zone, which is part of the high-grade feeder zone underlying Tuvatu and which comprises a major component of the mine plan. The completion of the link drive also enables mineralized lodes to be mined both from the historical exploration decline as well as from the main decline, thereby increasing the number of faces available to mine and adding considerable flexibility to the mining operations.
